# Manhole Inspection Summary

Manhole # S4900\_014MH

Insp Date: **3/17/08 10:55 AM**

**Location** Address: **Greenview**

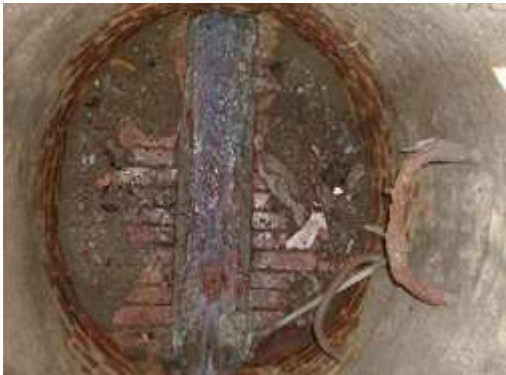
Top View

**Frame** Offset: **3** (in.) Condition: ☐ Sound ☐ Cracked ☒ **Leaks**

Condition: ☐ Sound ☐ Cracked ☐ Root Intrusion ☒ **Loose Brick** ☐ Deteriorated

Infiltration: ☐ None ☐ Joint ☐ Cracks ☒ **Mortar** ☐ Roots ☒ **Wall**
